ST STEPHEN PARISH COUNCIL

- 2526/AC/037 To discuss the drainage survey report and agree next steps in regard to drainage issues identified. Report attached.**
- 2526/AC/038 To receive the annual building inspection report and consider budget requirements for 2026-27. Report attached.**

Item for Submission to:
St Stephen Parish Council
Fixed Assets
Date of Meeting: 4 December 2025

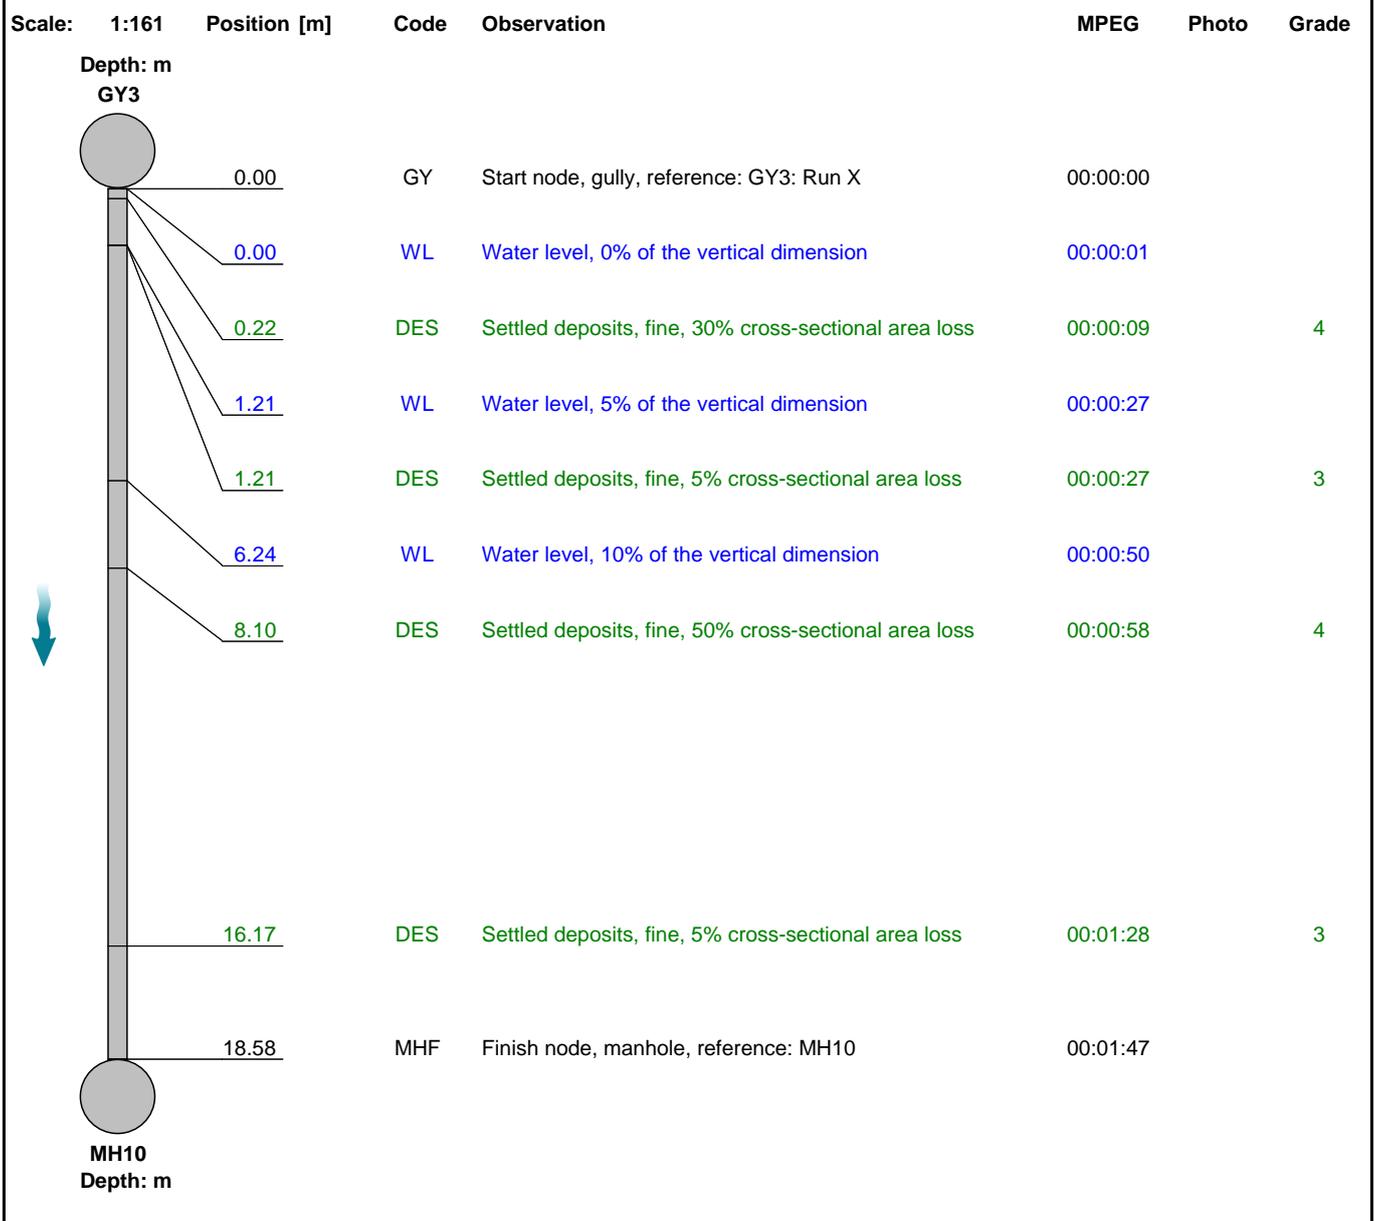
Section Inspection - 11/11/2025 - GY3X

Construction Features					Miscellaneous Features				
Structural Defects					Service & Operational Observations				
STR No. Def	STR Peak	STR Mean	STR Total	STR Grade	SER No. Def	SER Peak	SER Mean	SER Total	SER Grade
0	0.0	0.0	0.0	1.0	4	8.0	0.9	17.0	4.0

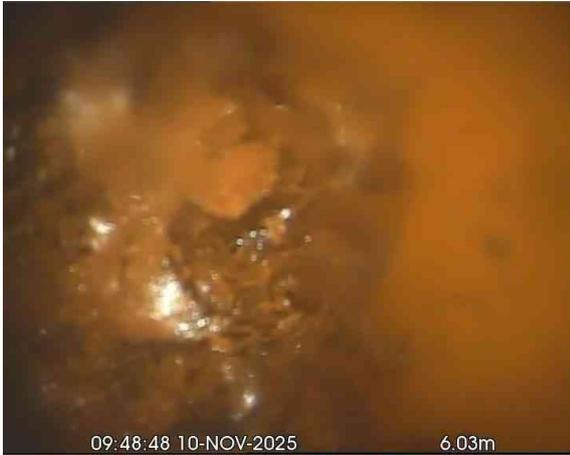
Item No.	Inspection Direction	PLR	Client's Job Ref	Contractor's Job Ref
14	Upstream	UNKNOWN2X

Unknown2X_7453e161-c589-4573-8f9f-8239d7d540b3_2025111_140247_352.jpg, 00:00:27, 6.03 m
Survey abandoned, Unable to continue due to deposit

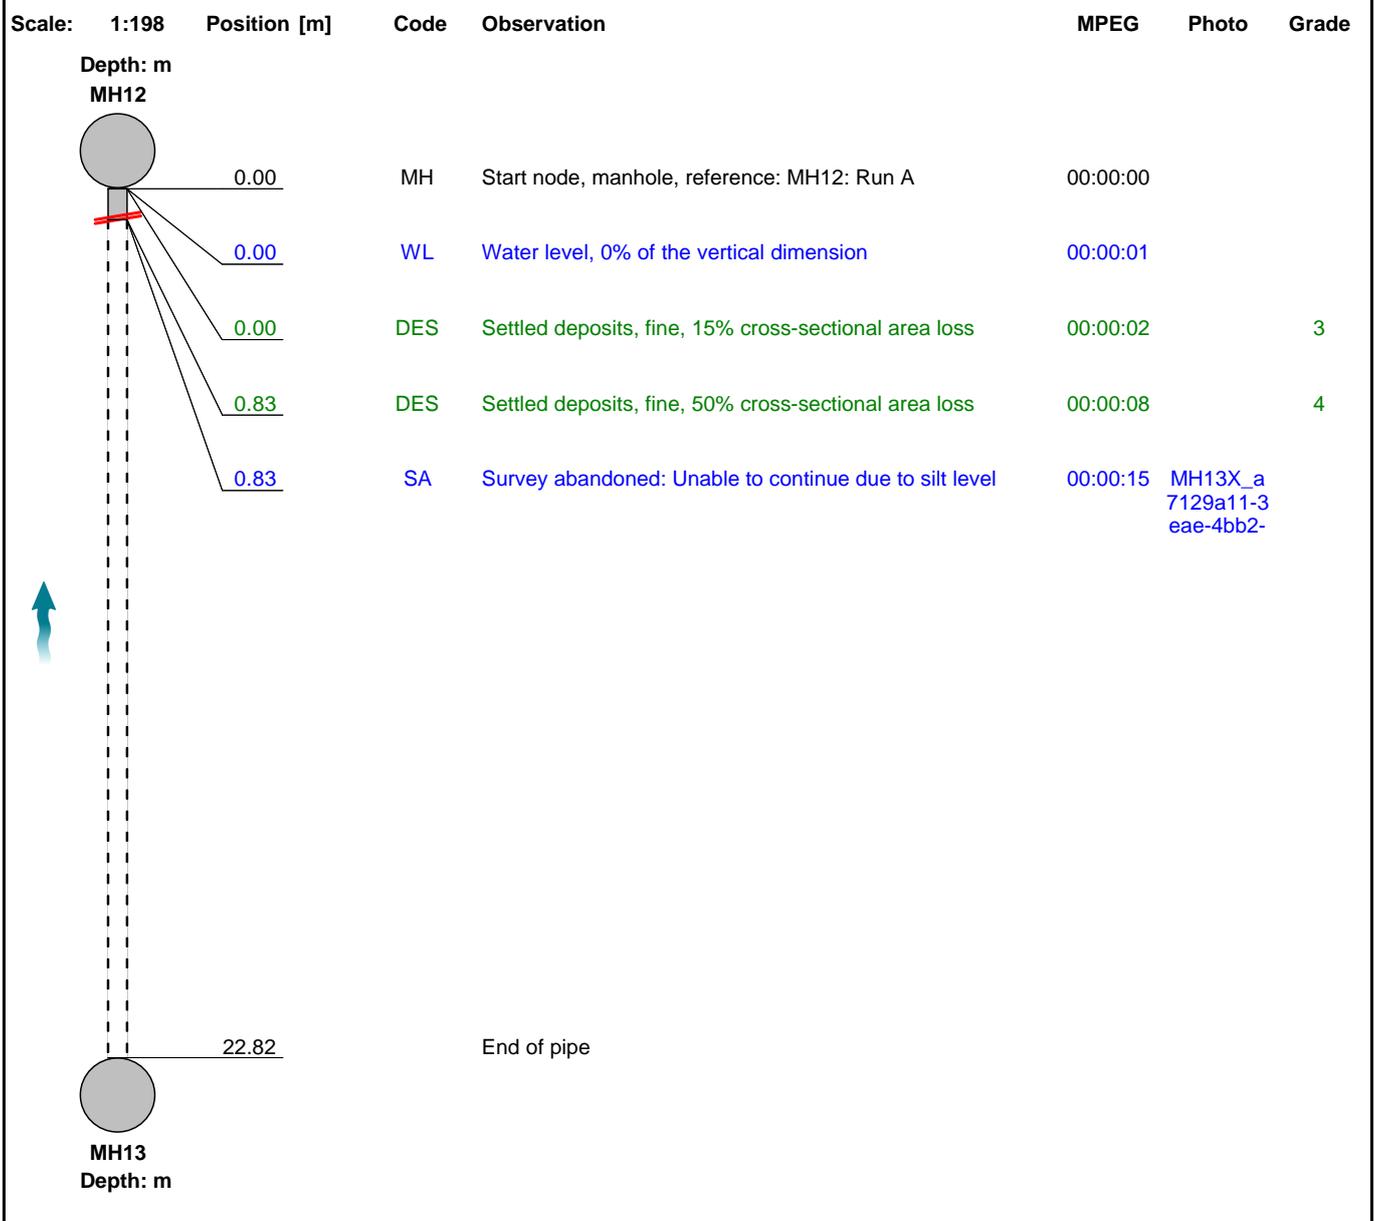
Construction Features					Miscellaneous Features				
Structural Defects					Service & Operational Observations				
STR No. Def	STR Peak	STR Mean	STR Total	STR Grade	SER No. Def	SER Peak	SER Mean	SER Total	SER Grade
0	0.0	0.0	0.0	1.0	2	8.0	11.1	10.0	5.0

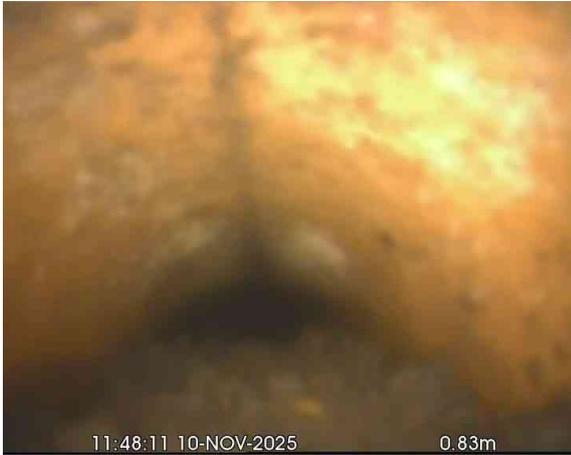
Item No.	Inspection Direction	PLR	Client's Job Ref	Contractor's Job Ref
29	Upstream	MH13X

MH13X_a7129a11-3eae-4bb2-80b2-1b3af833b408_20251111_144656_159.jpg, 00:00:15, 0.83 m

Survey abandoned, Unable to continue due to silt level
