ST STEPHEN PARISH COUNCIL

- 2526/AC/037 To discuss the drainage survey report and agree next steps in regard to drainage issues identified. Report attached.**
- 2526/AC/038 To receive the annual building inspection report and consider budget requirements for 2026-27. Report attached.**

Item for Submission to:
St Stephen Parish Council
Fixed Assets
Date of Meeting: 4 December 2025

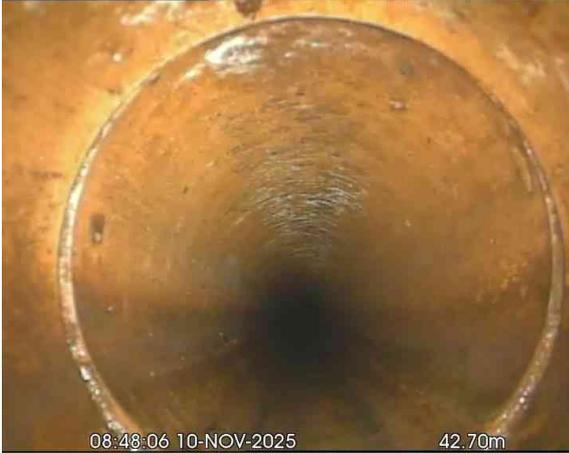
Item No.	Inspection Direction	PLR	Client's Job Ref	Contractor's Job Ref
6	Downstream	MH1X

MH1X_c6bf01cc-c345-48bf-85d6-d434b2b37cc3_20251111_1
32726_762.jpg, 00:03:06, 42.67 m
Survey abandoned, Unable to continue due to friction

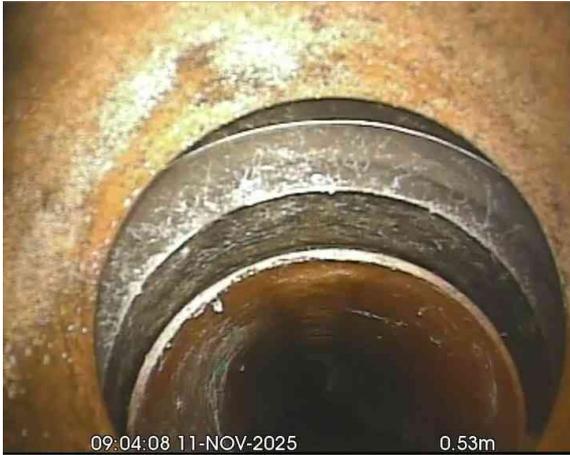
Item No.	Inspection Direction	PLR	Client's Job Ref	Contractor's Job Ref
29	Downstream	MH13X

Construction Features					Miscellaneous Features				
Structural Defects					Service & Operational Observations				
STR No. Def	STR Peak	STR Mean	STR Total	STR Grade	SER No. Def	SER Peak	SER Mean	SER Total	SER Grade
1	2.0	2.4	2.0	1.0	1	5.0	6.0	5.0	5.0

MH13X_184a149b-e022-4525-9fcd-ef94887853a7_20251111_145034_618.jpg, 00:00:18, 0.53 m
Survey abandoned, Unable to continue due to displaced joint

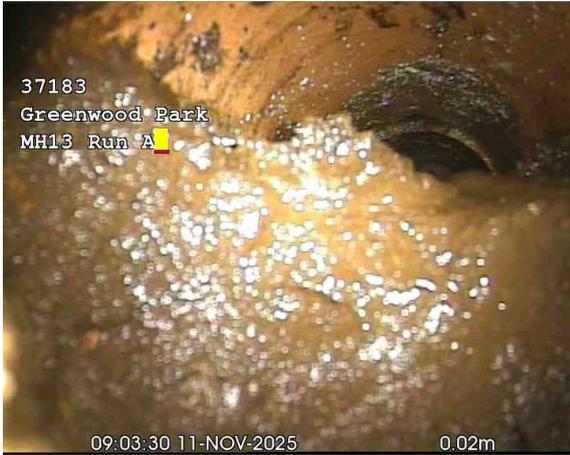
Item No.	Inspection Direction	PLR	Client's Job Ref	Contractor's Job Ref
31	Upstream	UNKNOWN3X

Unknown3X_2b750cde-30c7-4fd0-a133-f724b447d78a_2025111_145434.jpg, 0.00 m
Start node, manhole, reference: MH13, Run A

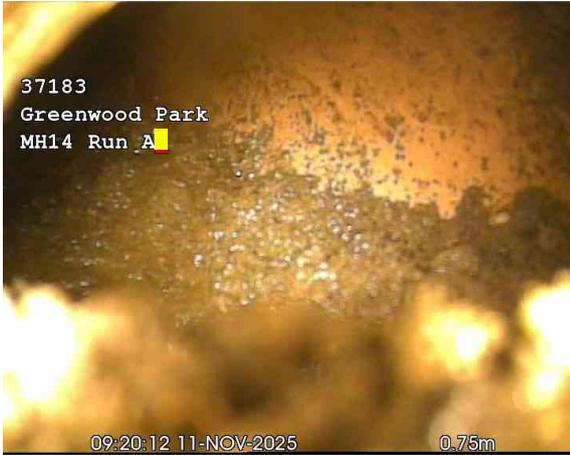
Item No.	Inspection Direction	PLR	Client's Job Ref	Contractor's Job Ref
32	Upstream	UNKNOWN4X

Unknown4X_08de5bac-bc6b-4199-8706-19744594bc34_2025
1111_145635.jpg, 0.00 m
Start node, manhole, reference: MH14, Run A
